Inspection Report

Carl Lester Freeman
216 Honeysuckle Ln
Florence, SC 29506

Insp Date: 4/14/2008

File # 136

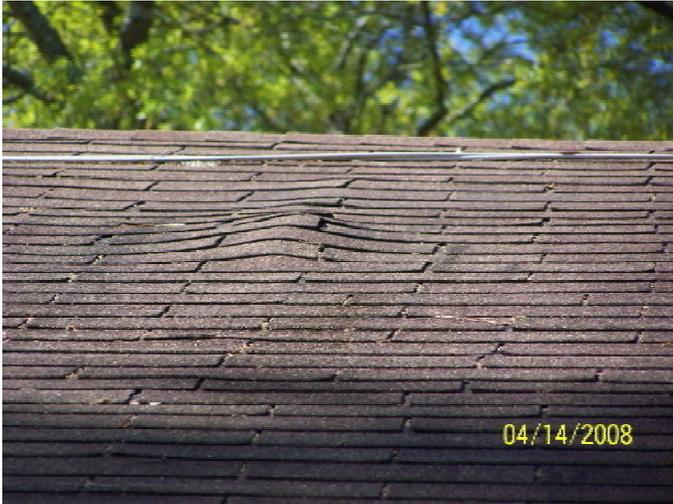
There is a damaged area in the roof that is inaccessible due to finished area in attic.

Roof Damage Noted

Recommend evaluation by roofing contractor.

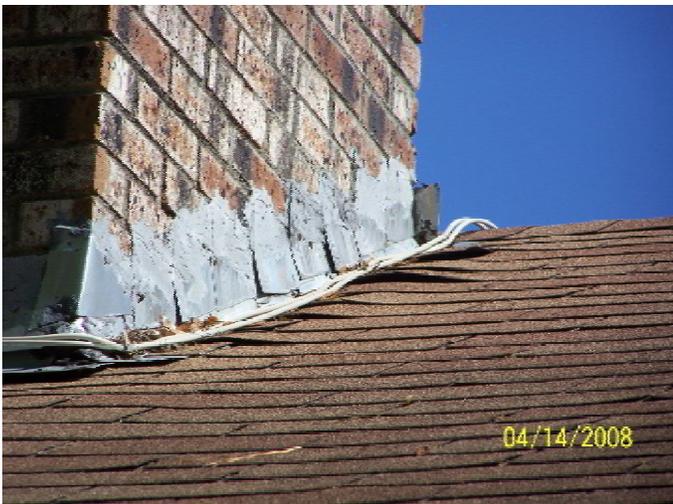
The chimney flashing has been repaired. This is usually a sign that it has been leaking, and it is also generally a sign that the flashing was improperly installed in the first place. If it is not currently leaking, it will likely do so soon. Tared and chalked chimney flashing are always a high-maintenance item, unless the tar and old flashing are removed and new flashing are properly installed. Some raised shingles are noted around this area.

Chimney Flashing Resealed
